Manhole Inspection Summary

Manhole # S29M__001MH

Insp Date: **4/7/09 9:53 AM**

Location Address: **601 SCOTT ST**

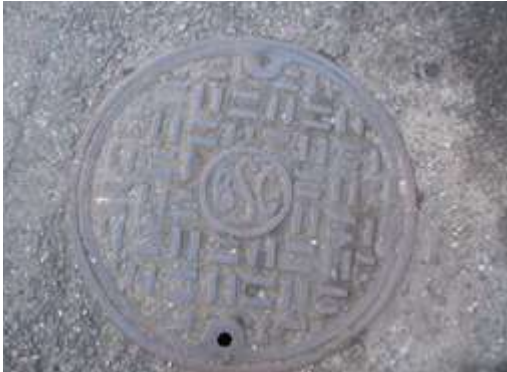
COVER PIC

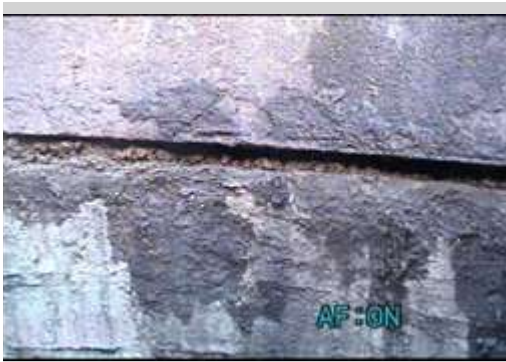
Defect 3

Condition: ☐ Sound ☐ Cracked ☒ **Leaks**

INFILTRATION LID/FRAME

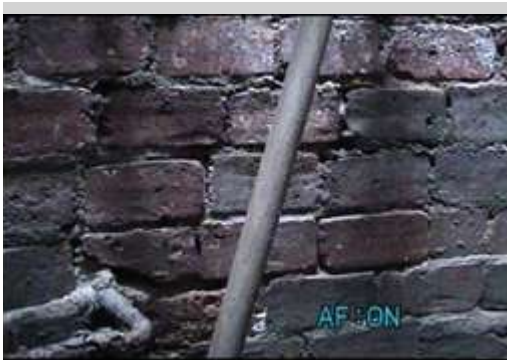
Defect 2

Condition: ☐ Sound ☐ Cracked ☐ Root Intrusion ☐ Loose Brick ☒ **Deteriorated**

Infiltration: ☐ None ☐ Joint ☐ Cracks ☒ **Mortar** ☐ Roots ☐ Wall

DETERIORATED BARREL & infiltration

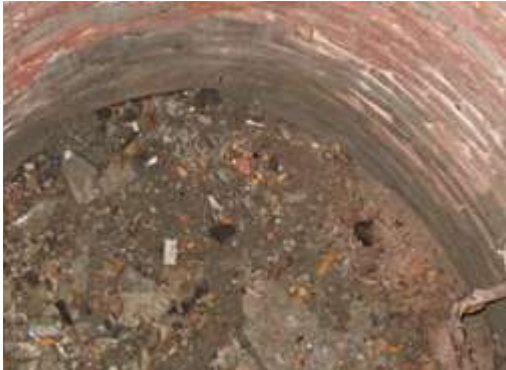
Defect 4

Condition: ☐ Sound ☐ Cracked ☐ Root Intrusion ☐ Deteriorated ☐ Leaks ☒ **Debris**

Debris

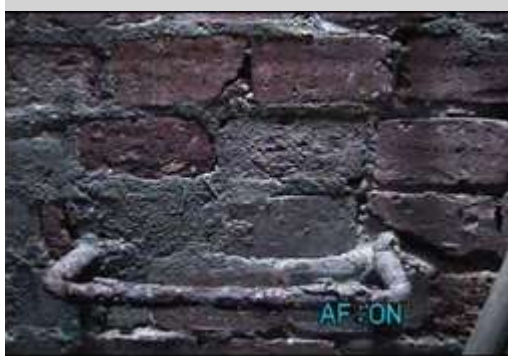
Defect 4

Count: **6** Missing: **0** ☒ **Corroded**

CORRODED RUNG

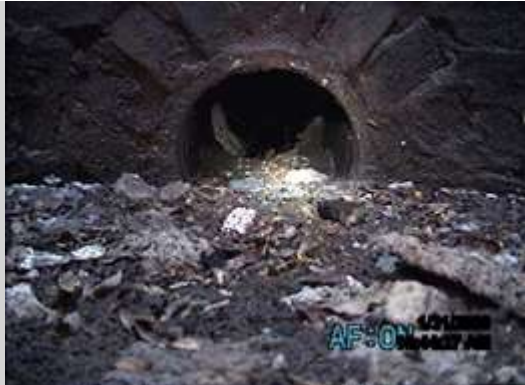
12 O'Clock Outflow

8 in. Circular Gravity Sewer
Pipe Out @ 12 O'Clock
